**A SPATIAL AND TEMPORAL 3D SLAB-BASED METHODOLOGY
FOR OPTIMIZED CONCRETE PAVEMENT ASSET
MANAGEMENT**

A Dissertation
Presented to
The Academic Faculty

In Partial Fulfillment
of the Requirements for the Degree
Doctor of Philosophy in the
School of Civil and Environmental Engineering

Georgia Institute of Technology
December 2019

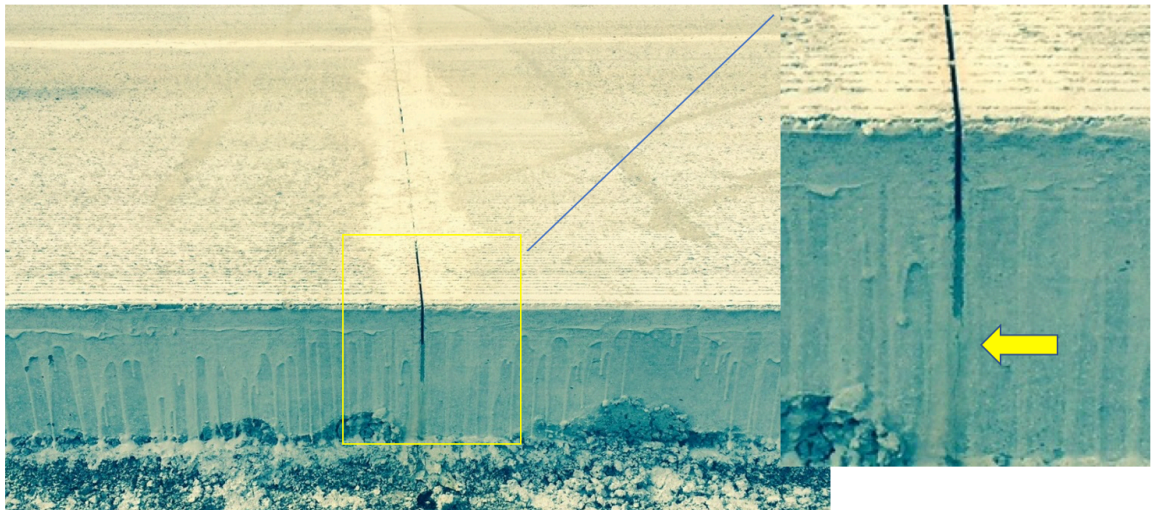
Figure 2-1 Cracking below a notched joint in JPC Pavement (taken at Illinois Tollway, 2015)

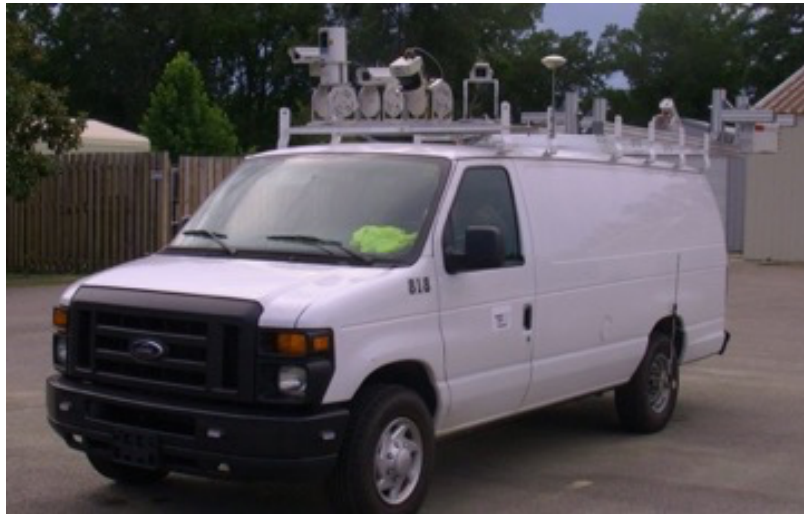
Figure 3-1 Georgia Tech Sensing Vehicle (GTSV)

direction. In addition to collecting GPS, DMI, and 3D pavement data, GTSV can also collect LiDAR (Light Detection and Ranging) data for inventorying roadway and roadside assets, such as signs [Ai et al., 2015 and Ai et al., 2016], pavement markings, and guardrails.

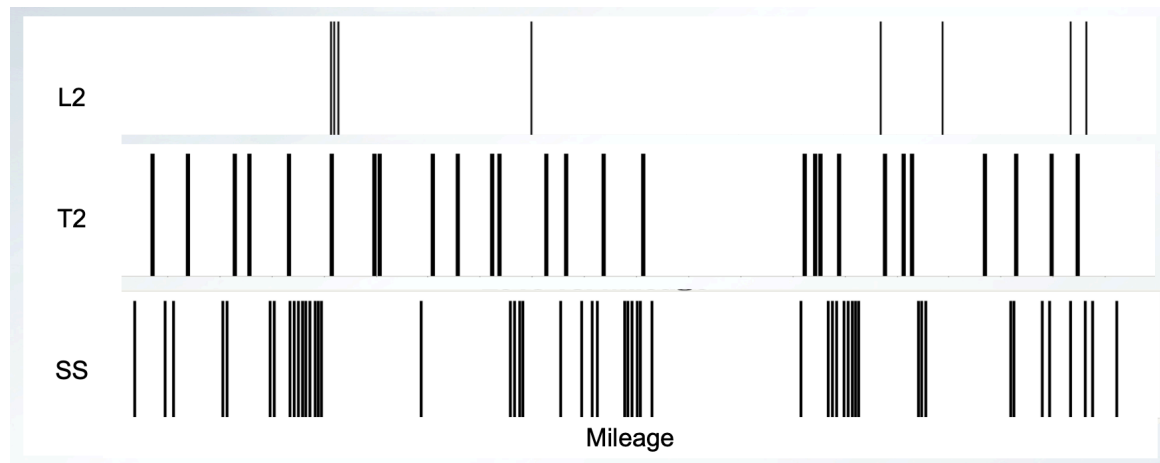
Figure 3-12 Spatial Distribution of different types of cracking

actual slabs. The top slabs are the L2 slabs, the middle shows the distribution of T2 slabs and the bottom depicts the SS slabs. The patterns that were identified in LTPP pavements and discussed in Section 2.3 are evident in this section. The L2 slabs are more clustered, without any pattern. The T2 slabs are distributed in a random normal format. The SS slabs appear to be a combination of the L2 and T2 distributions, also as expected, especially since the SS slabs developed almost equally from slabs that were originally longitudinally or transversely cracked (see Appendix for additional details).

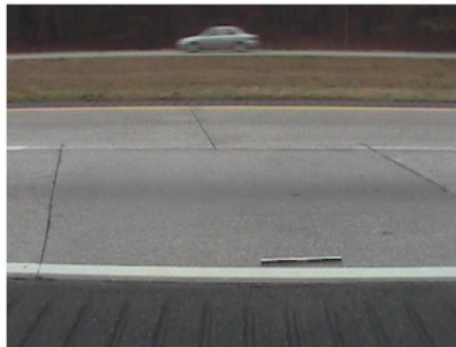
Figure A-5 Replaced slab in LTPP Section 13-3017
